KINGSTON RECOVERY PROGRAM MANAGEMENT SITE MONTHLY REPORT

June, 2013

Aerial Image of Kingston Ash Slide (05/01/2013)

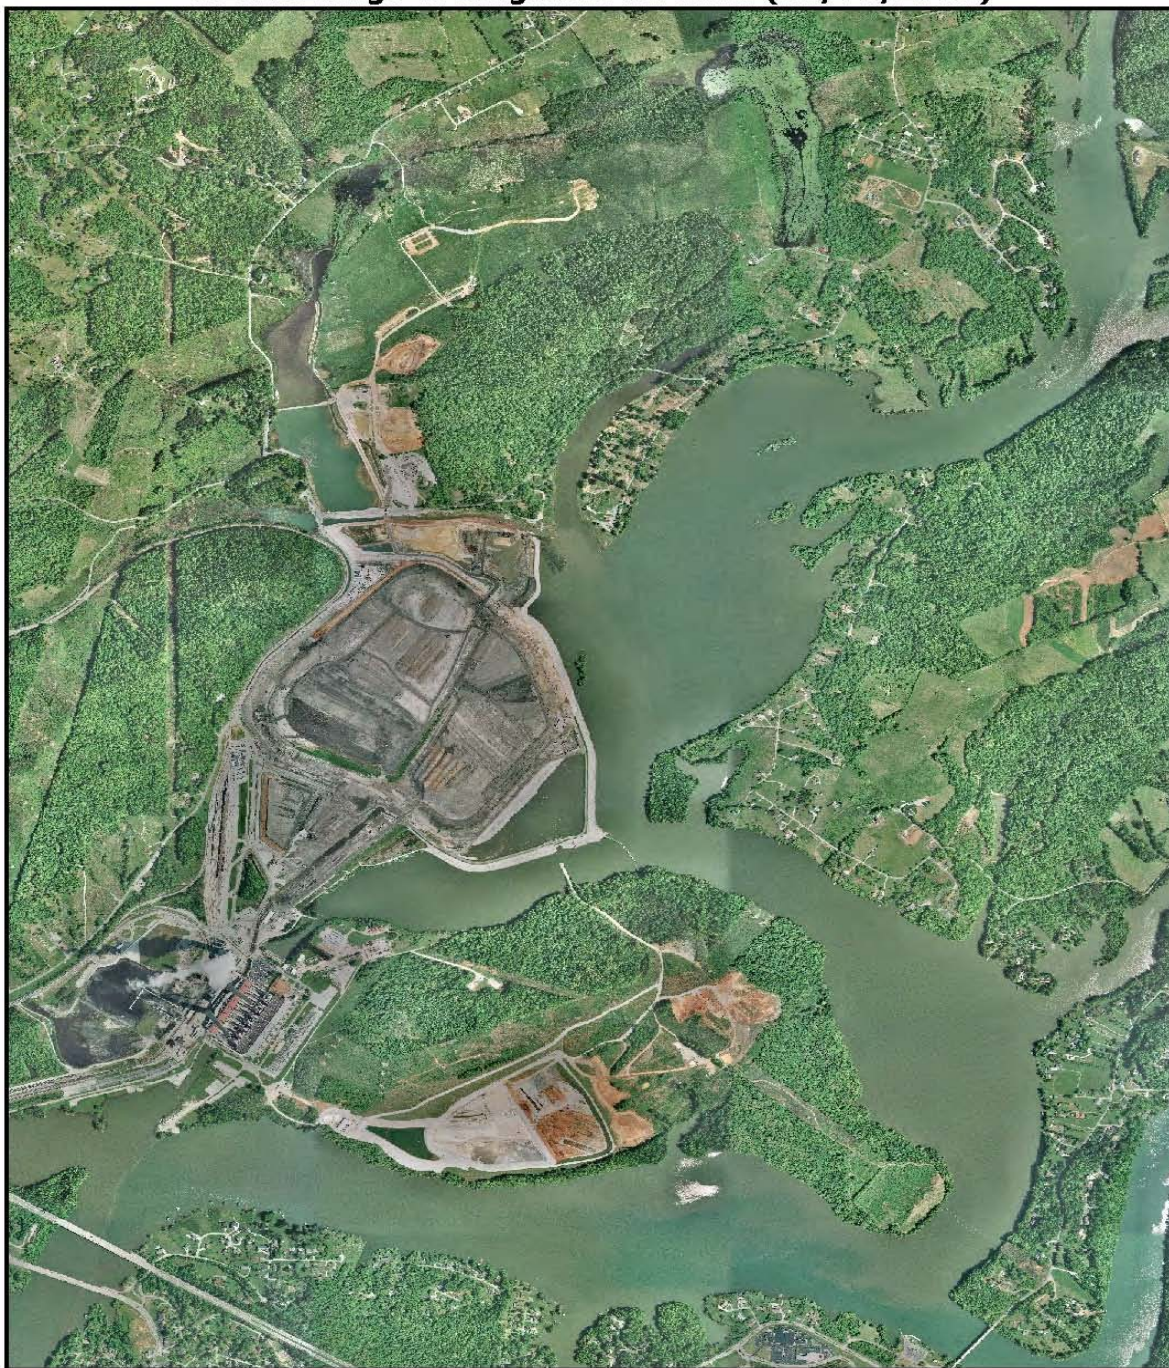
Date of imagery: 05/01/2013

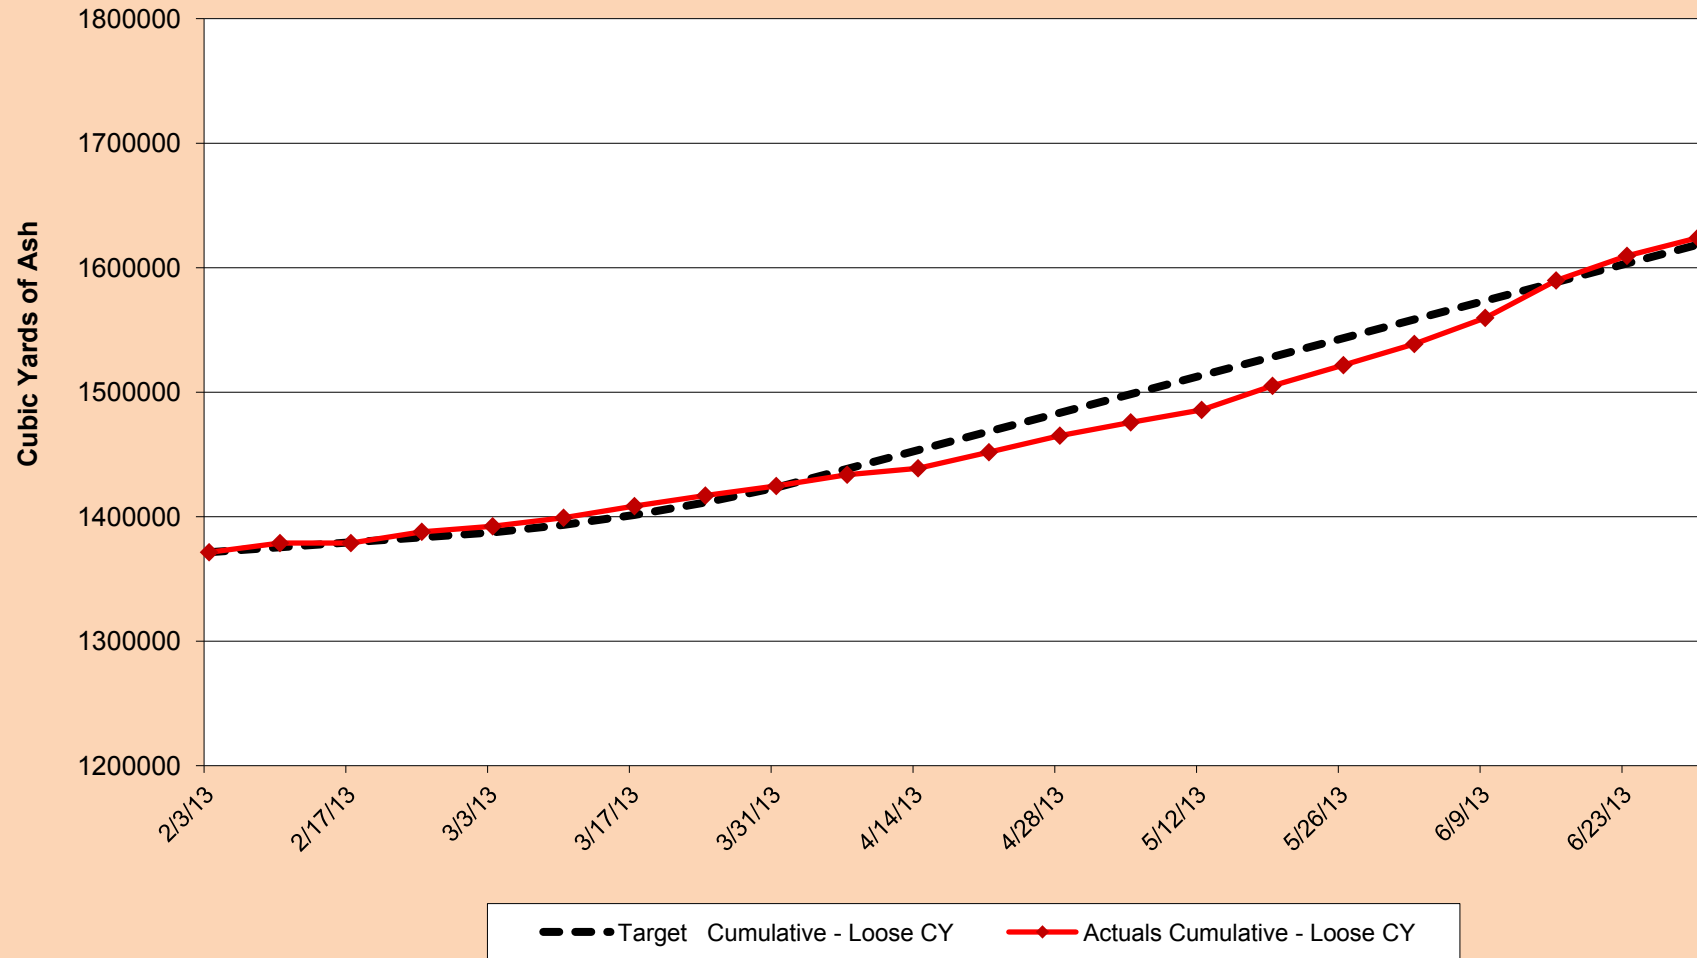
**Ash Excavation from Middle Embayment
Weekly as of June 30, 2013**

- Ash removal from the Middle Embayment was carried out during June, 2013.
- Ash removal along the Clean Water Ditch completed and emphasis was switched to removal of bulk ash associated with T-2 sediment pond and associated berms.
- Bulk ash removal was completed in late June 2013 and work was switched to removal of Buttress Toe and J Road material to allow completion of the wall buttress near T-3 dike.
- Weekly Middle Embayment status reports were submitted.

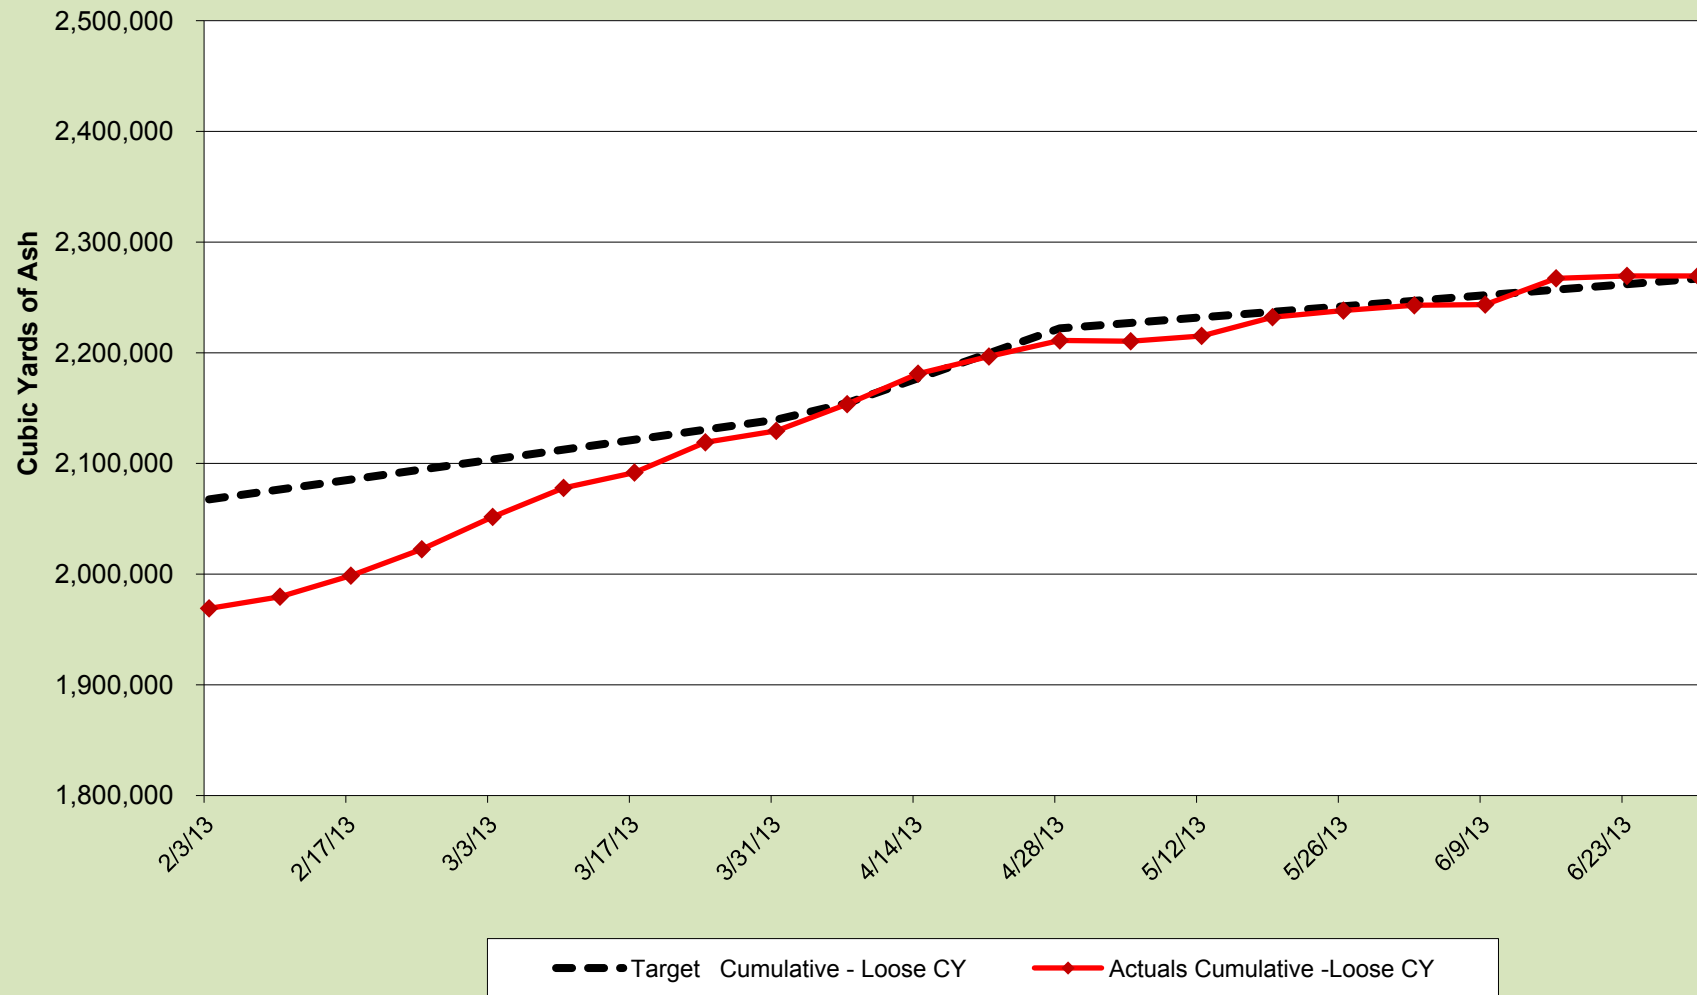
Ash Stacking in Dredge Cell Weekly as of June 30, 2013

- Completed Segment 1 perimeter berm construction, bringing the berm to final grade and fixing erosion damage.
- Completed ash stacking next to the Segment 1 berm and resumed stacking next to Segment 7, including excavating the corner of the Relic in Cap Area II.

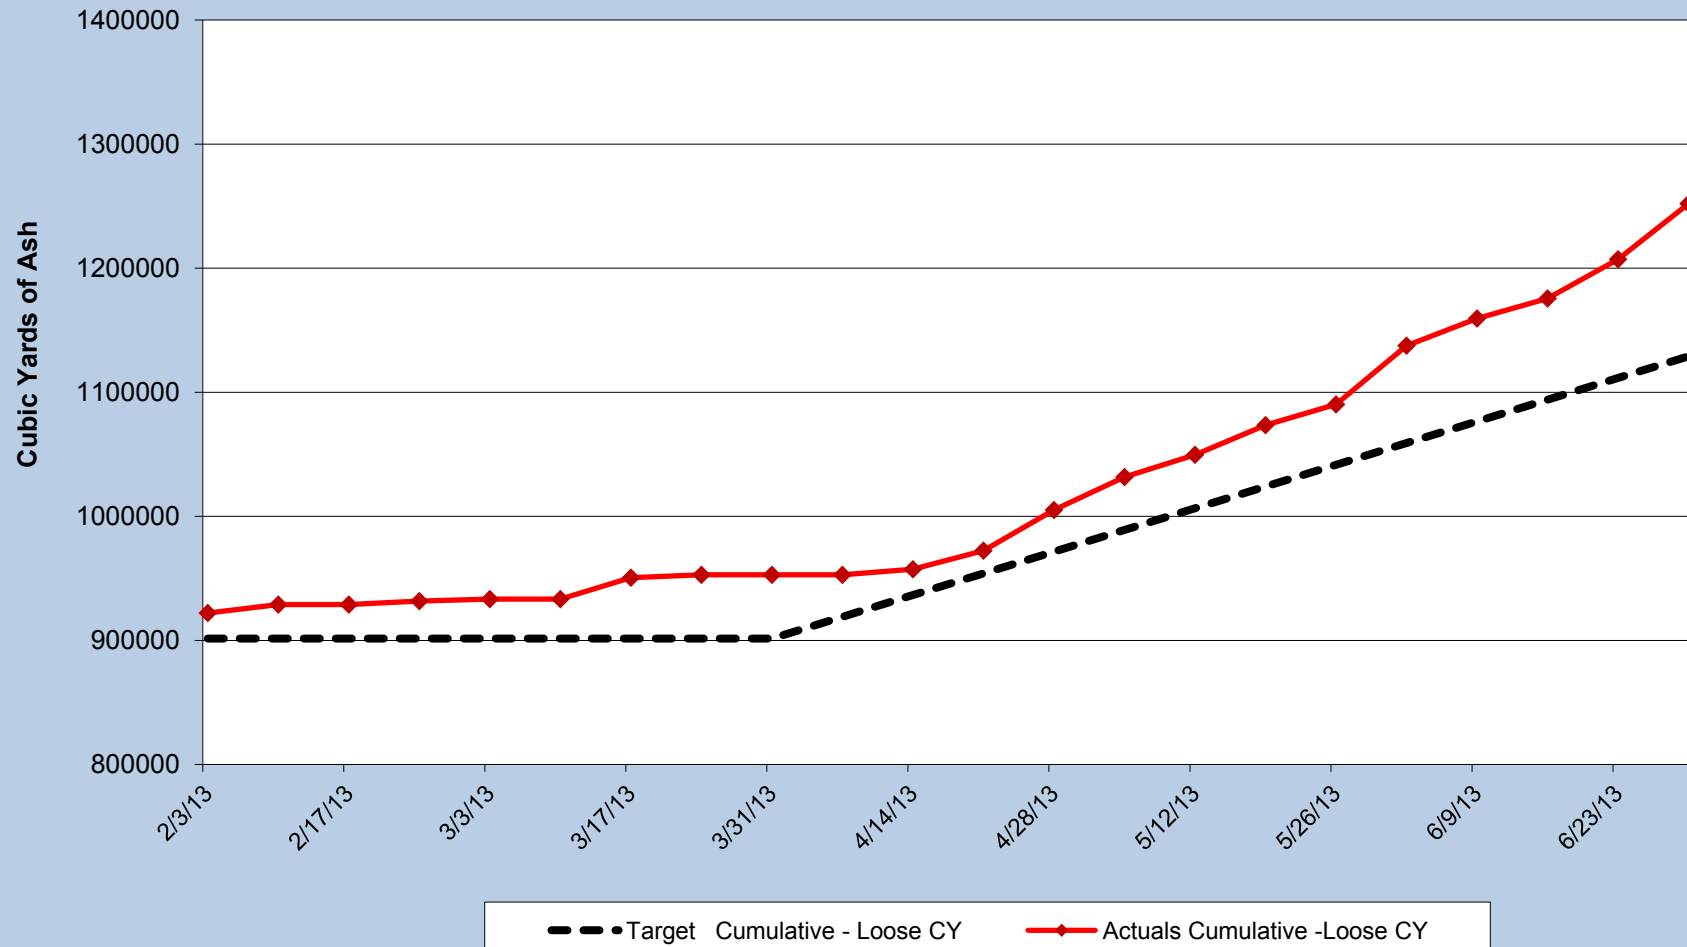
Ash Stacking in Lateral Expansion Weekly as of June 30, 2013

- Began dressing spoils piles along Segment 2 in preparation for berm construction.
- Continued ash stacking in the Lateral Expansion as weather permitted.
- S&ME completed mitigation coring (secondary round of coring) in Segment 2, and continued first round of coring in Segment 3 with a total of 5 rigs.
- Geo-Con continued predrilling and jet grouting for defect repairs in Segment 2 and began repairs in Segment 3.
- Removed windrow piles in the Ash Pond and resumed stacking within the Ash Pond.

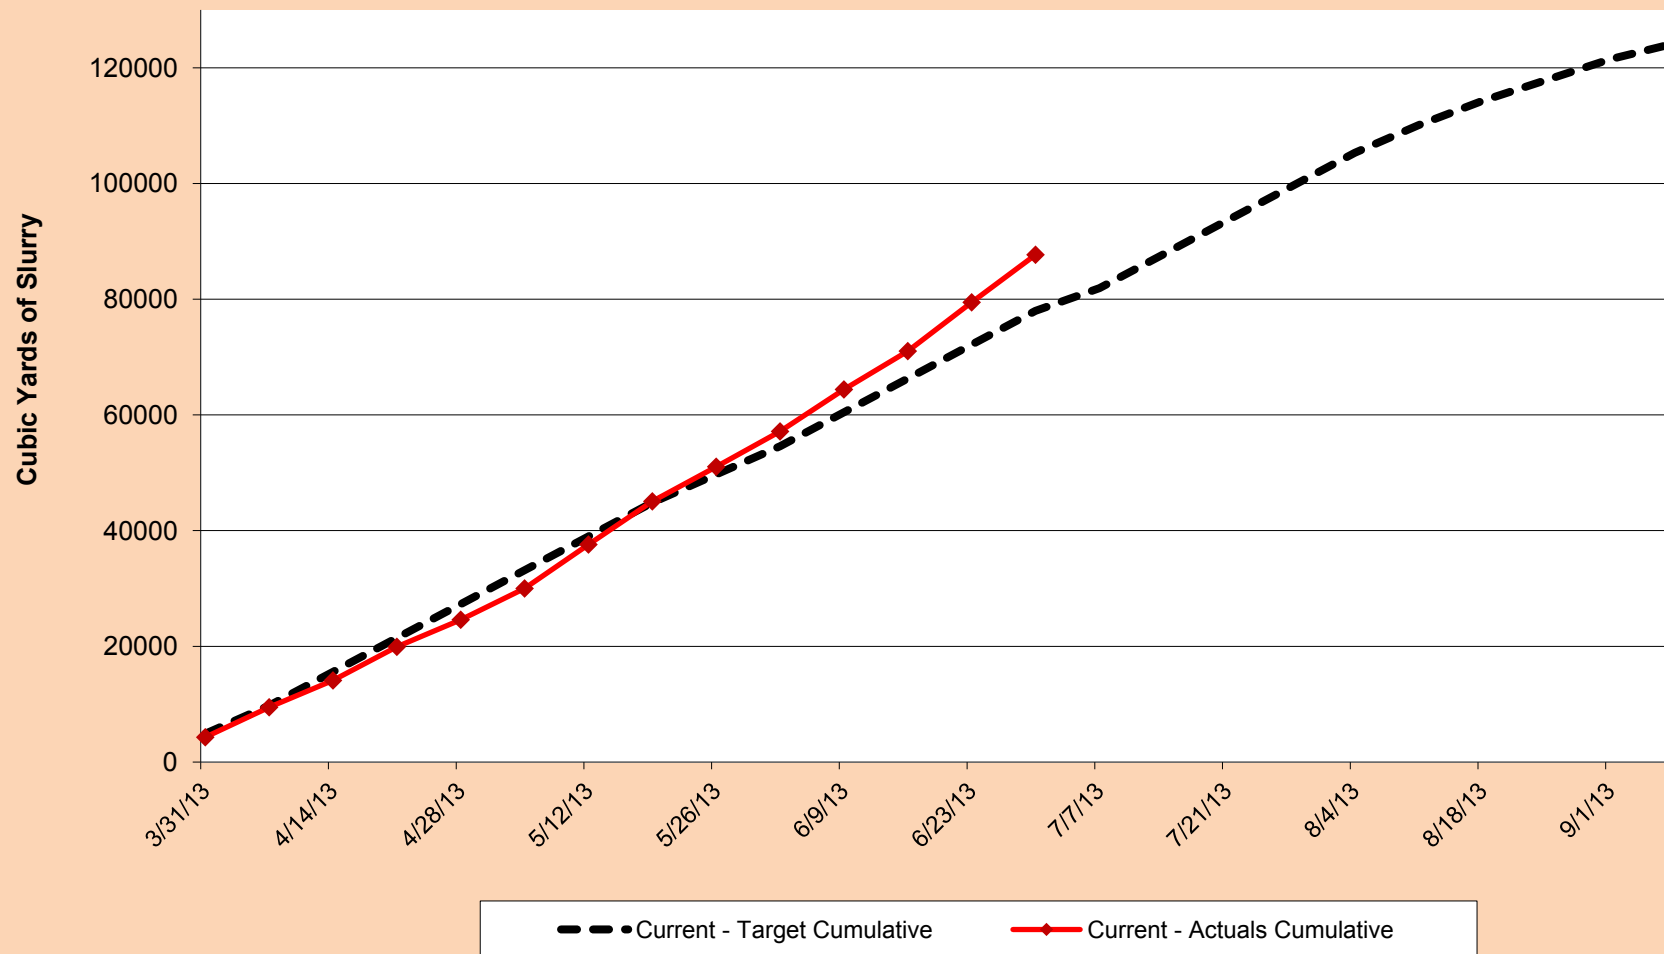
Perimeter Wall Stabilization Segments 5 and 6 Weekly as of June 30, 2013

- Geo-Con continued perimeter wall stabilization (PWS) construction on Segments 5 and 6.
- Griffin continued operating the deep and shallow well points for dewatering of both Segments 6 and 5.
